Intel[®] Atom[™] Processor E6xx Series

Specification Update

July 2014

Revision 017

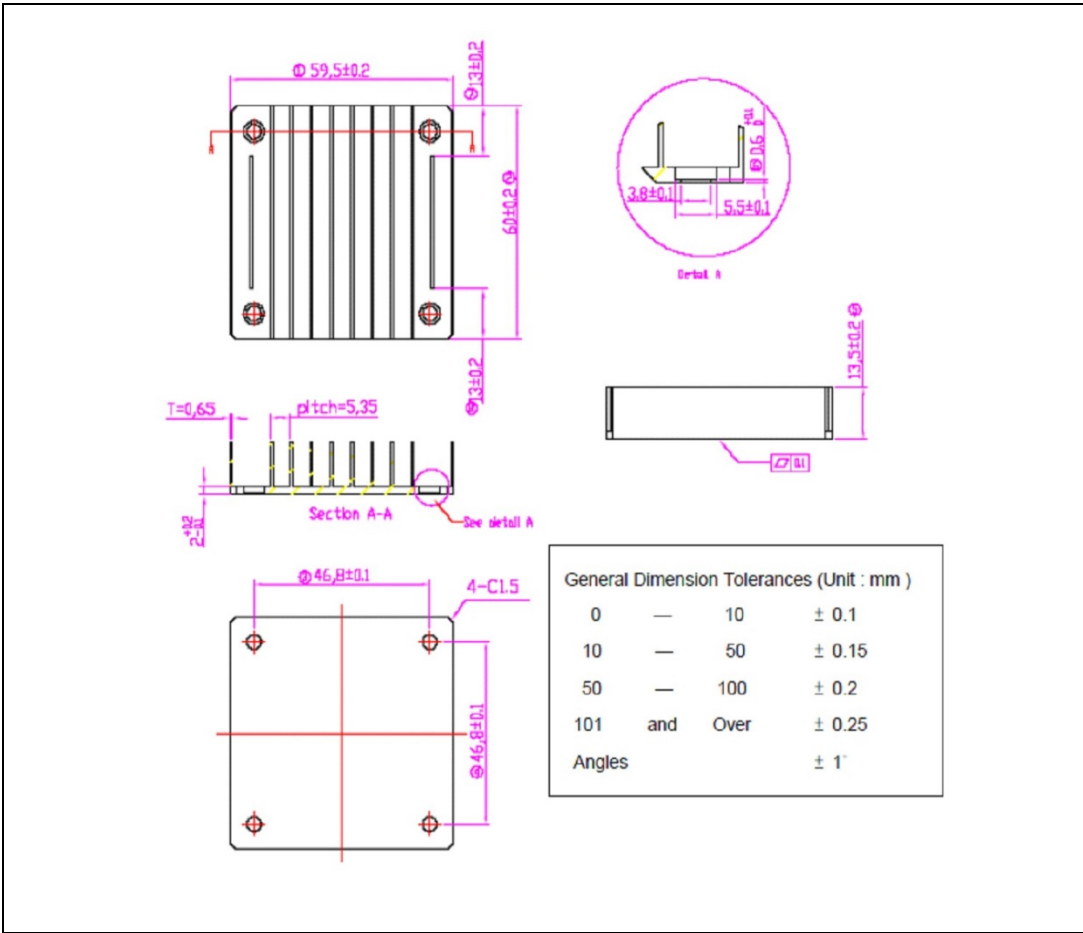
Figure 10. 1U Natural Convection Heatsink Mechanical Drawing

Old Text:

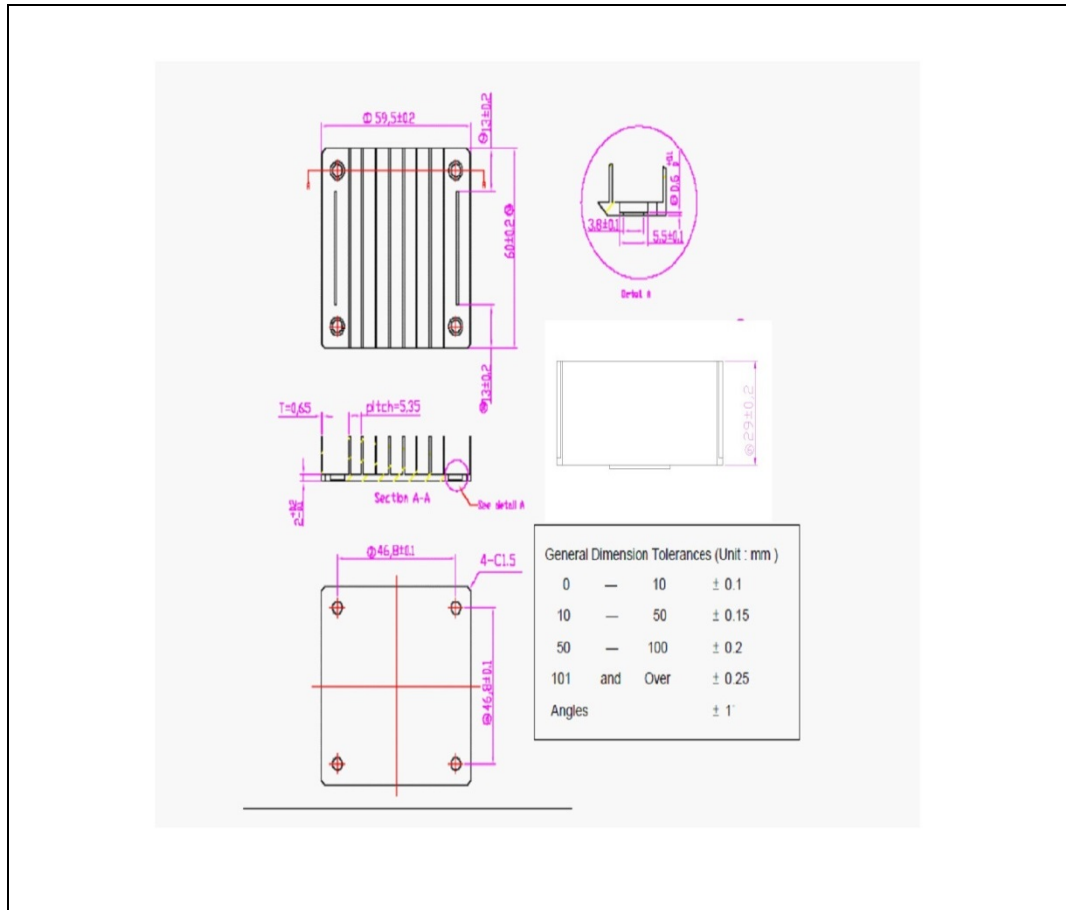
Figure 10. 1U Natural Convection Heatsink Mechanical Drawing

New Text:

Affected Docs: Figure 10 "1U Natural Convection Heatsink Mechanical Drawing" of *Intel® Atom™ Processor E6xx Series Thermal and Mechanical Design Guidelines*, Rev 003.
