MSP430F5637 Device Erratasheet

7 Detailed Bug Description

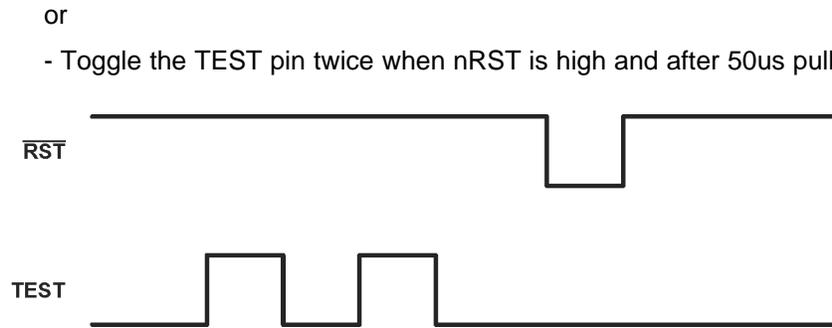
Description The methods used to exit the BSL per MSP430 Programming Via the Bootstrap Loader ([SLAU319](#)) are invalid.

Note: This toggling of TEST pins is not subject to timing constraints. The appropriate level transitions on TEST pin, followed by a RST pulse after 50us, are sufficient to trigger an exit from BSL mode.

Workaround To exit the BSL one of the following methods must be used.
- A Power cycle
