TMS320F2806x Piccolo™ MCUs

Silicon Revisions B, A, 0

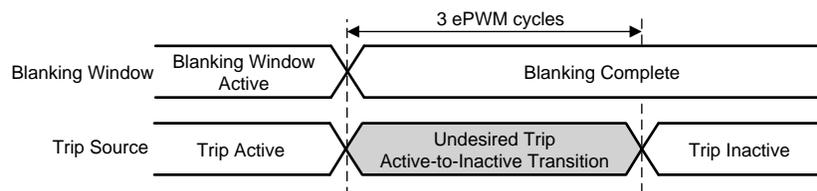
Figure 6. Undesired Trip Event and Blanking Window Expiration

Details The blanking window is typically used to mask any PWM trip events during transitions which would be false trips to the system. If an ePWM trip event remains active for less than three ePWM clocks after the end of the blanking window cycles, there can be an undesired glitch at the ePWM output.

Figure 6 illustrates the time period which could result in an undesired ePWM output.
