# **TMS320F2837xD Dual-Core MCUs Silicon Revisions C, B, A, 0**

This document describes the silicon updates to the functional specifications for the TMS320F2837xD microcontrollers (MCUs).

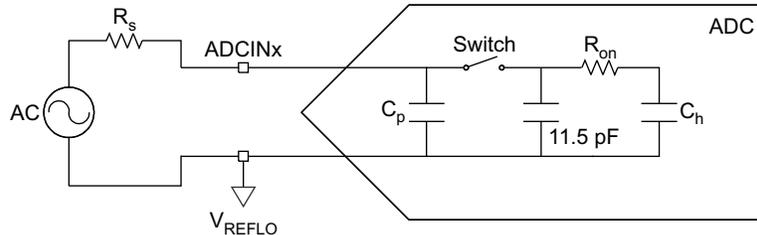
**Figure 3. Single-Ended Input Model**

**Details** The ADC input model should be used to select the sample-and-hold (S+H) duration for each ADC input. For the revisions affected, if the currently converting channel is an even-numbered channel and the previously converted channel was an odd-numbered channel (or vice versa), then the 12-bit input model will not accurately predict ADC input performance. Under these conditions, an additional capacitance should be added to the model. This capacitance has a value of 11.5 pF and should be placed between the S+H switch and  $R_{on}$  as shown in [Figure 3](#).

**Workaround(s)** For the revisions affected, when subsequent conversions switch between channel groups, the S+H duration should be chosen to account for the additional capacitance.

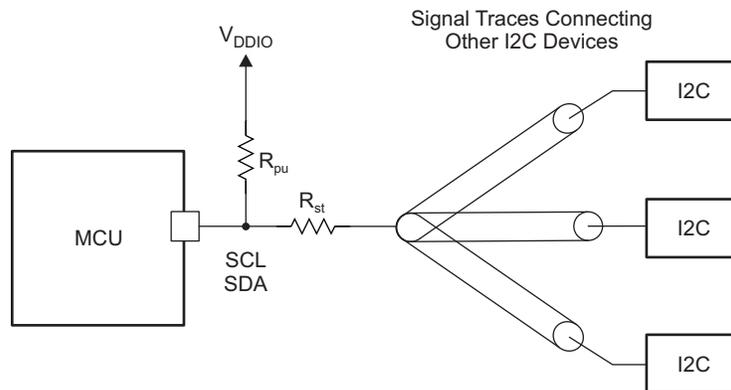
**Figure 7. Placement of Series Termination Resistor and Pullup Resistor**

The SDA and SCL outputs are implemented with push-pull 3-state output buffers rather than open-drain output buffers as required by I2C. While it is possible for the push-pull 3-state output buffers to behave as open-drain outputs, an internal timing skew issue causes the outputs to drive a logic-high for a duration of 0–5 ns before the outputs are disabled. The unexpected high-level pulse will only occur when the SCL or SDA outputs transition from a driven low state to a high-impedance state and there is sufficient internal timing skew on the respective I2C output.

This short high-level pulse injects energy in the I2C signals traces, which causes the I2C signals to sustain a period of ringing as a result of multiple transmission line reflections. This ringing should not cause an issue on the SDA signal because it only occurs at times when SDA is expected to be changing logic levels and the ringing will have time to damp before data is latched by the receiving device. The ringing may have enough amplitude to cross the SCL input buffer switching threshold several times during the first few nanoseconds of this ringing period, which may cause clock glitches. This ringing should not cause a problem if the amplitude is damped within the first 50 ns because I2C devices are required to filter their SCL inputs to remove clock glitches. Therefore, it is important to design the PCB signal traces to limit the duration of the ringing to less than 50 ns. One possible solution is to insert series termination resistors near the SCL and SDA terminals to attenuate transmission line reflections.

Insert series termination resistors on the SCL and SDA signals and locate them near the SCL and SDA terminals. The SCL and SDA pullup resistors should also be located near the SCL and SDA terminals. The placement of the series termination resistor and pullup resistor should be connected as shown in [Figure 7](#).

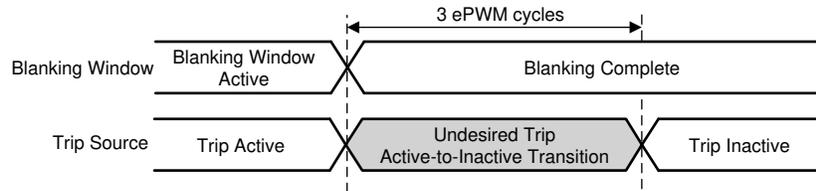
**Figure 8. Undesired Trip Event and Blanking Window Expiration**

**Details** The blanking window is typically used to mask any PWM trip events during transitions which would be false trips to the system. If an ePWM trip event remains active for less than three ePWM clocks after the end of the blanking window cycles, there can be an undesired glitch at the ePWM output.

Figure 8 illustrates the time period which could result in an undesired ePWM output.
