Intel® Core™2 Extreme Processor QX9000^Δ Series and Intel® Core™2 Quad Processor Q9000^Δ, Q9000S^Δ, Q8000^Δ and Q8000S^Δ Series

Specification Update

— on 45 nm Process in the 775-land LGA Package

Document Number: 318727- 025

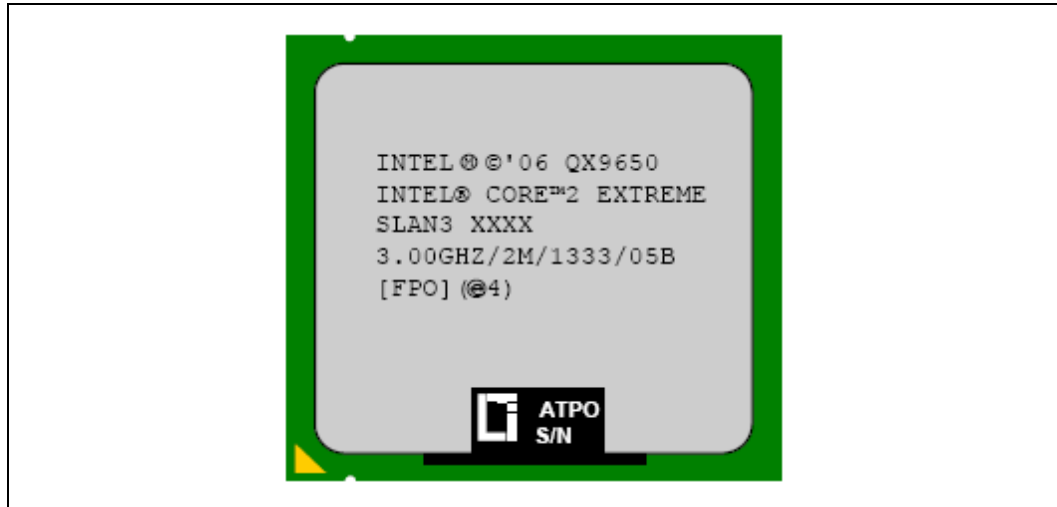
Figure 1. Processor Top-Side Markings Example (Intel® Core™2 Extreme Processor QX9650)
