# Intel<sup>®</sup> Core<sup>™</sup>2 Extreme Processor QX9000<sup>Δ</sup> Series and Intel<sup>®</sup> Core<sup>™</sup>2 Quad Processor Q9000<sup>Δ</sup>, Q9000S<sup>Δ</sup>, Q8000<sup>Δ</sup> and Q8000S<sup>Δ</sup> Series

## Specification Update

— on 45 nm Process in the 775-land LGA Package

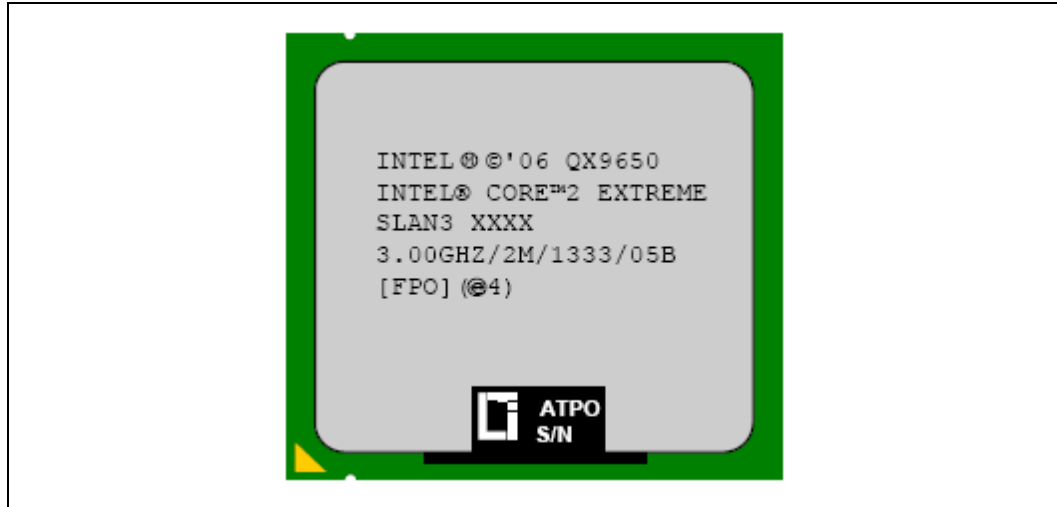
Figure 1. Processor Top-Side Markings Example (Intel® Core™2 Extreme Processor QX9650)
