Intel[®] IXP42X Product Line of Network Processors and IXC1100 Control Plane Processor

Specification Update

October 2004

Document Number: [252702-006](#)

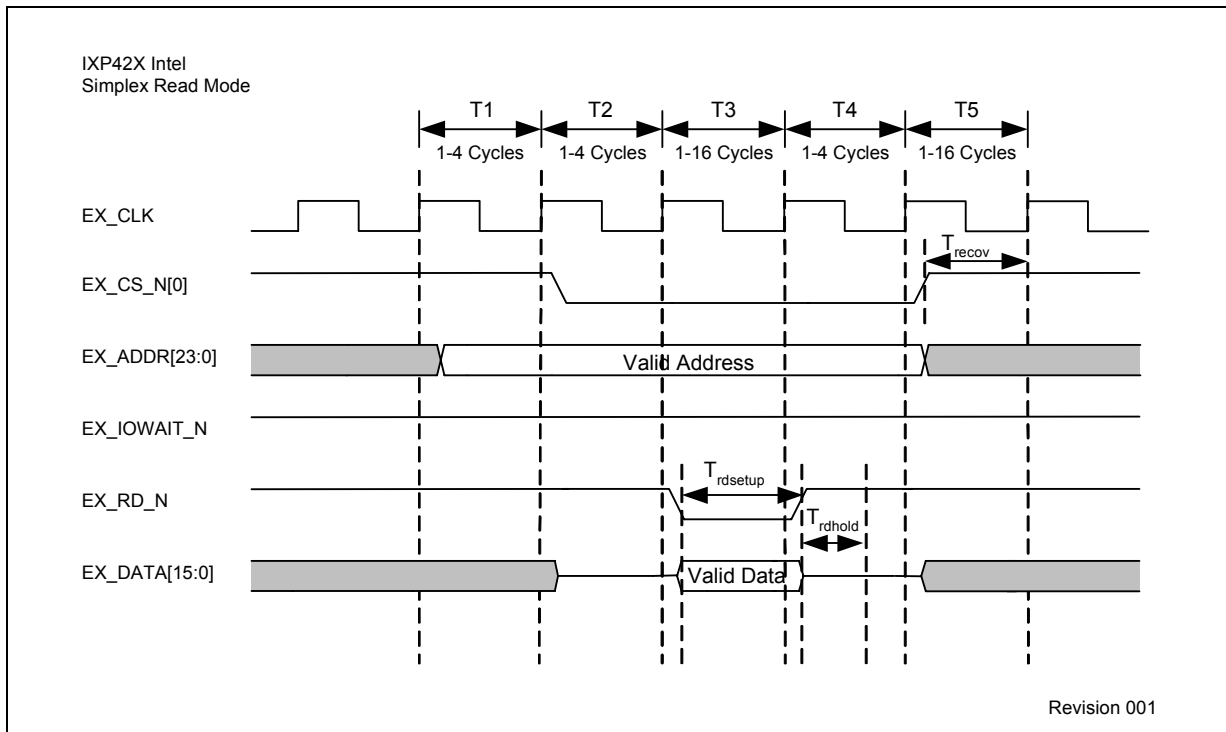
Intel® Simplex Read Mode

Replace datasheet Figure 26, “Intel® Simplex Mode”, with the following two figures, “Intel® Simplex Read Mode”, and “Intel® Simplex Write Mode”.

Issue: In the Intel® IXP42X Product Line of Network Processors and IXC1100 Control Plane Processor Datasheet, several Expansion Bus timing diagrams are incorrect. Figures 25–33 are affected.

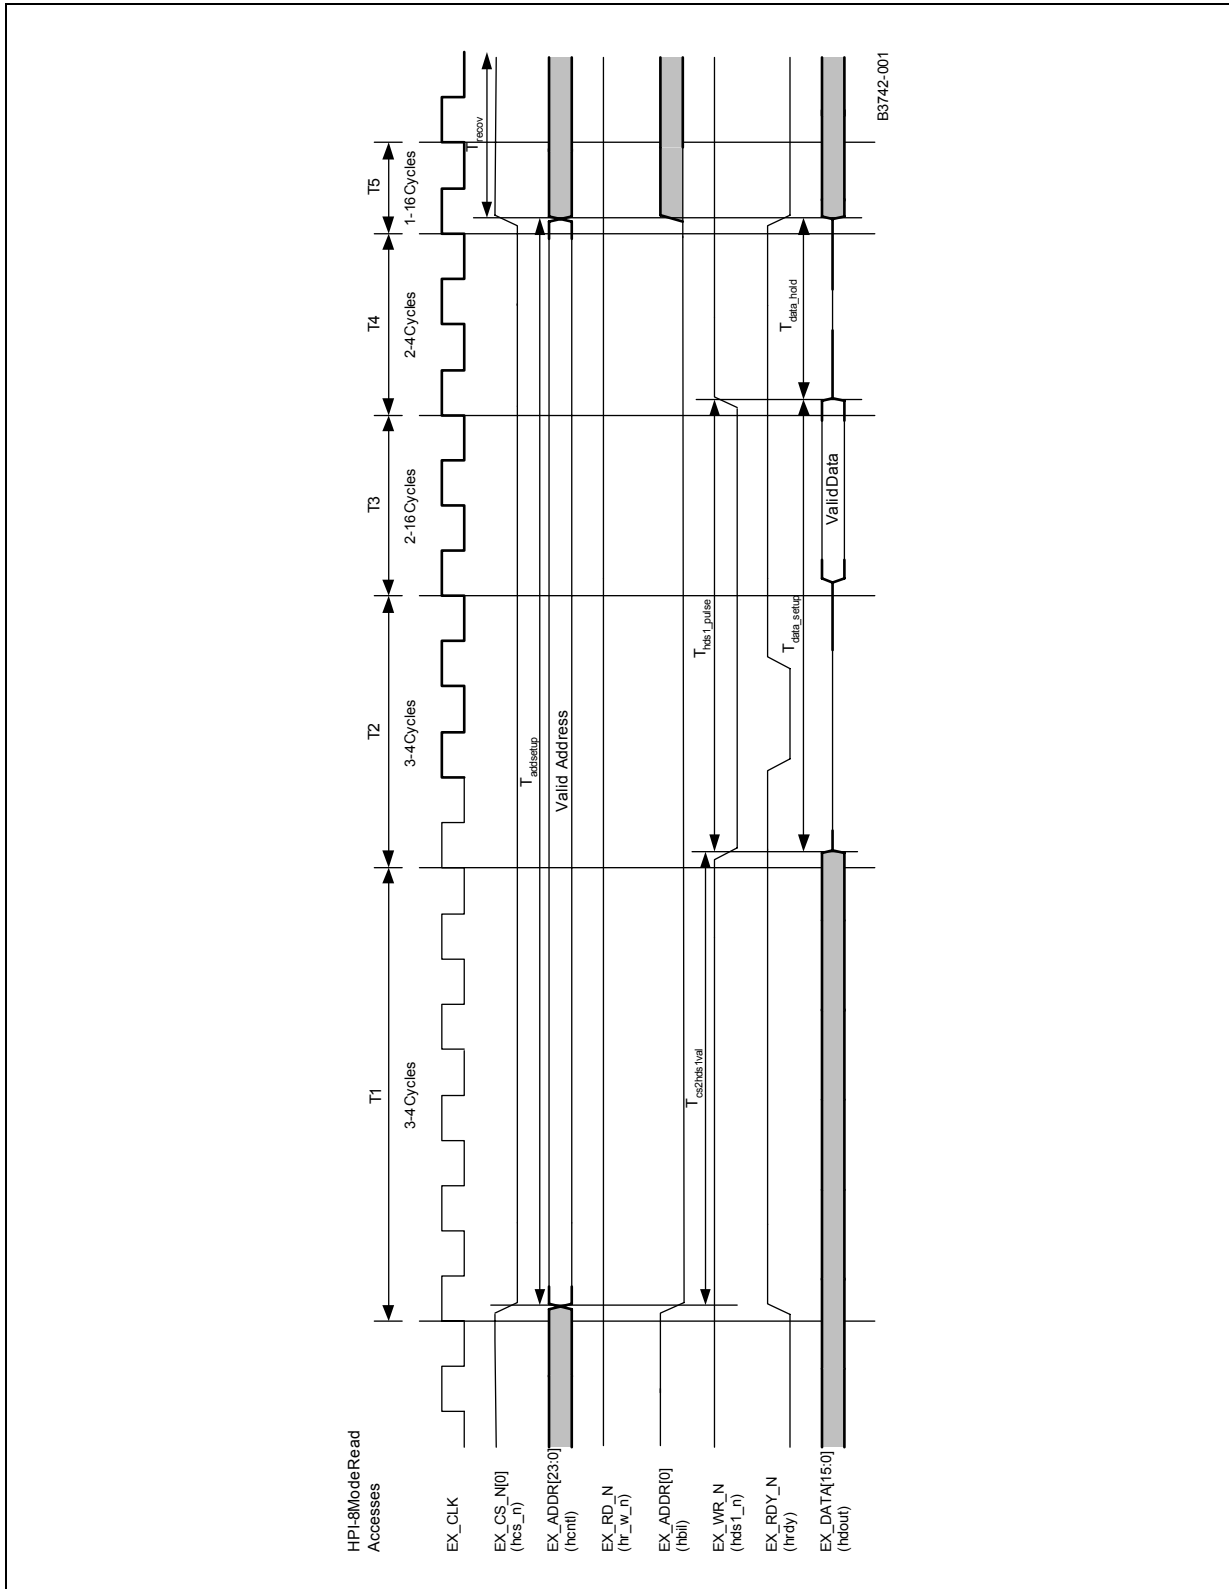
HPI-8 Mode Read Accesses

Replace datasheet Figure 30, “HPI-8 Mode Read Accesses”, with a new figure, “HPI-8 Mode Read Accesses”, which follows.
